NASA CR-2075

**RESIDUAL STRENGTH AND CRACK
PROPAGATION TESTS ON
C-130 AIRPLANE CENTER WINGS
WITH SERVICE-IMPOSED FATIGUE DAMAGE**

Prepared by
LOCKHEED-GEORGIA COMPANY
Marietta, Ga. 30060
for Langley Research Center

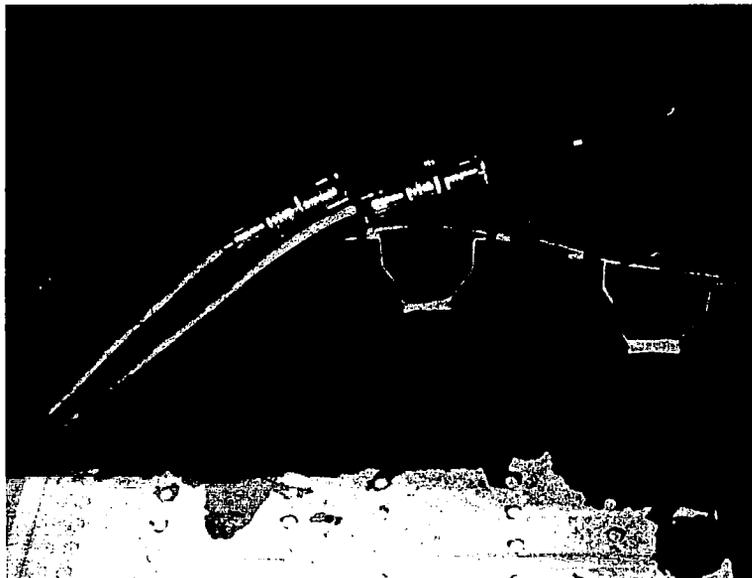
Test Specimen #1. Test failure is shown in Figure 9. Close-up of failure in Figure 10 shows lower surface cross-section details, including hat section stringers. Several regions of the upper surface experienced compression-type secondary failures.

Figure 10.
Specimen #1.
Static test,
lower surface.
Close-up of failure
near aft wing spar.

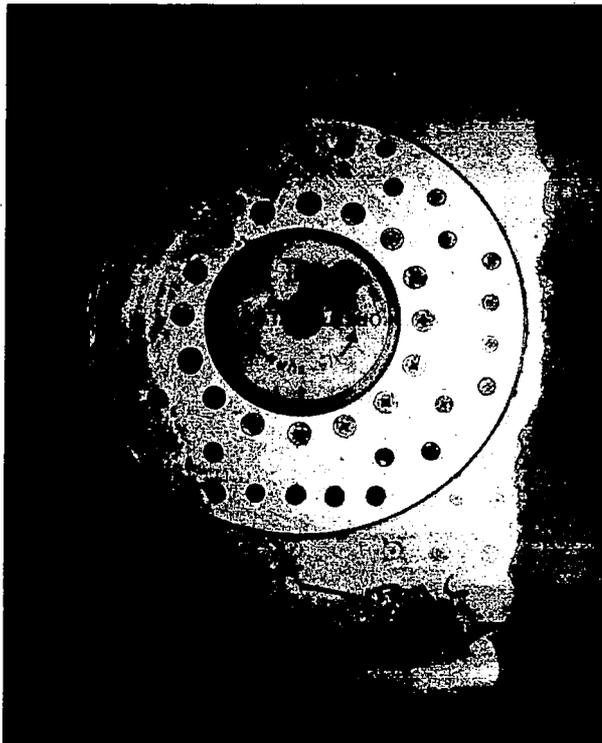
Figure 16.
Specimen #6.
Static test,
upper surface.
Final cracking
at WS 120.5
fuel filler hole.

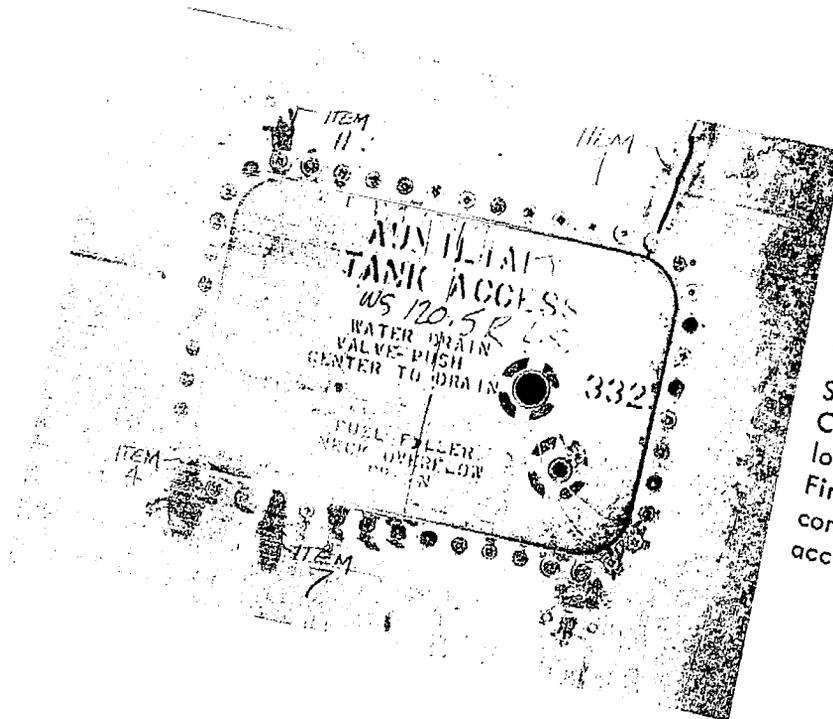
Test Specimen #5. A 1.1 inch crack at the corner of the door cutout at W. S. 113R was the only initial damage detected, and as shown in Figure 24 (Item 1), it propagated to only 4 inches during the entire test, and was not associated with eventual specimen failure.

Figure 24.
Specimen #5.
Cyclic & static testing,
lower surface.
Final cracking at
corners of WS 120.5R
access door.

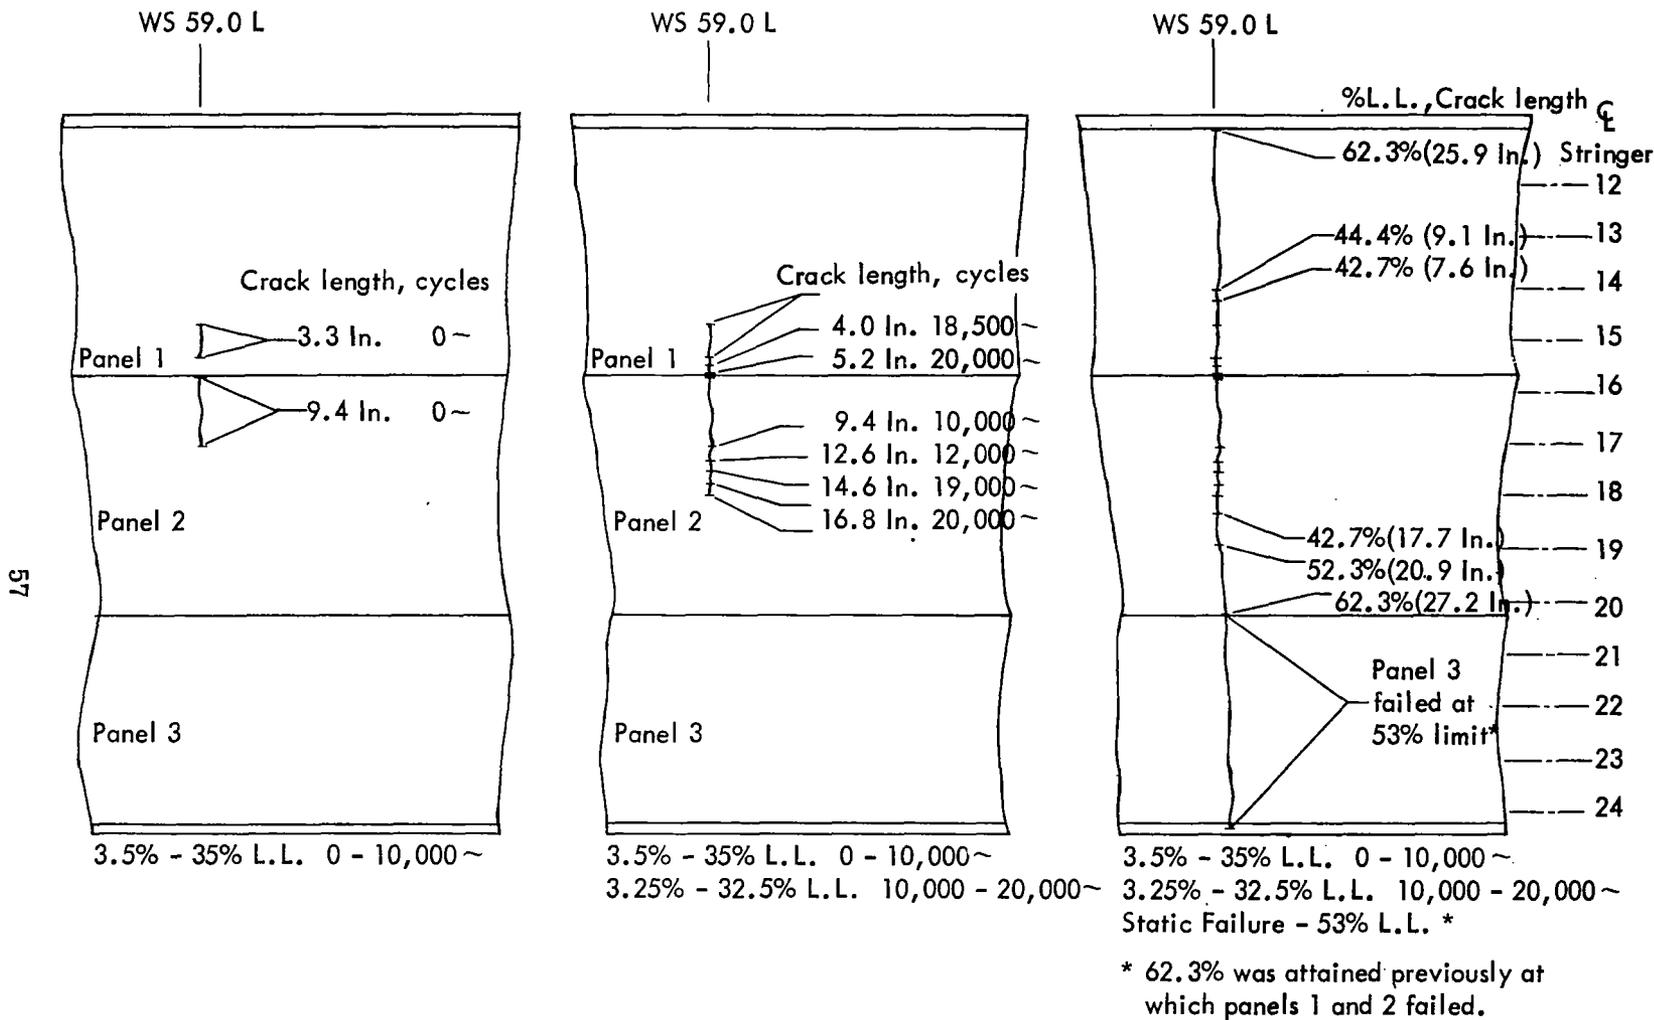
Figure 30 - Test specimen #13, progression of crack propagation to failure at W.S. 59L.

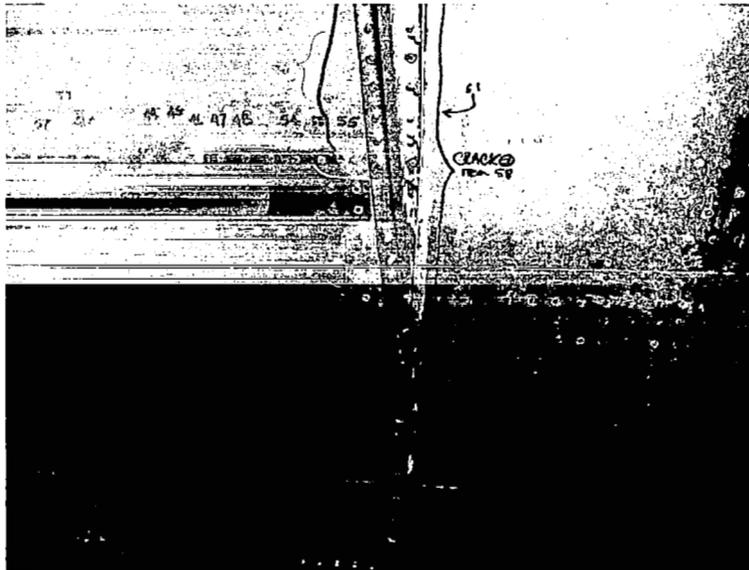
Figure 33.

Specimen #14.
Cyclic & static test,
lower surface.
Long crack along thrust
angle, aft region, WS 179R -
damage after test cycling.

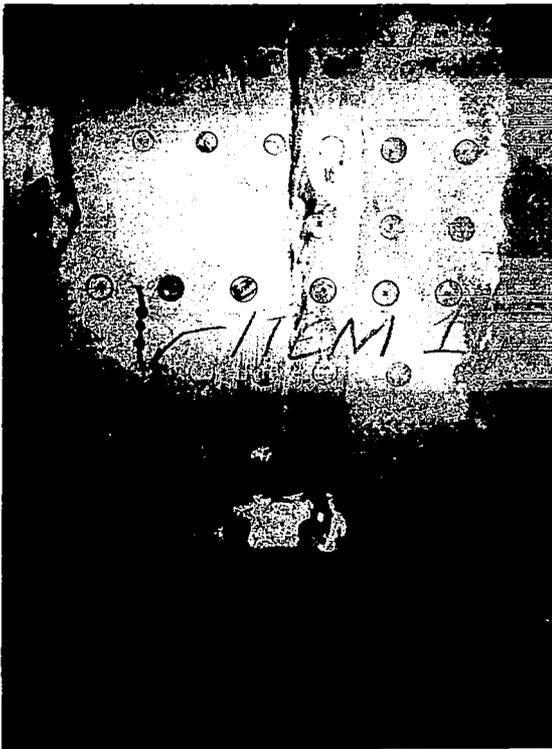
Figure 35. Specimen #9,
Cyclic & static test,
upper surface.
Initial crack of 3.6
inches at WS 34.5L.

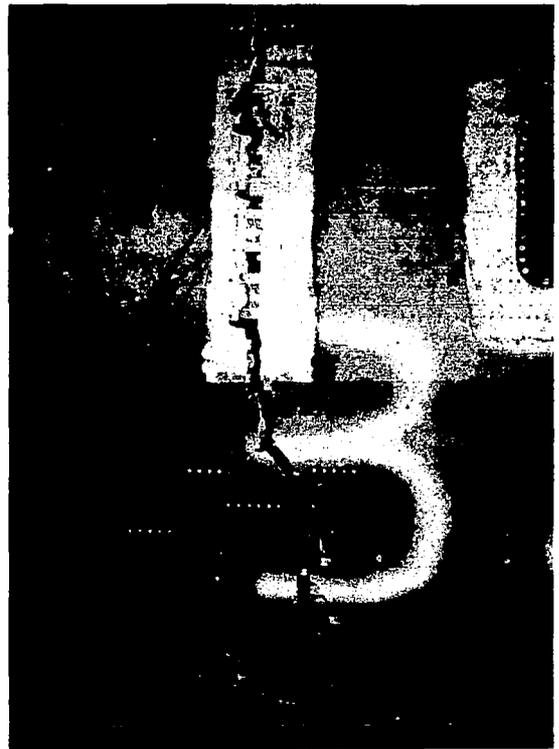
Figure 36. Specimen #9.
Cyclic & static test,
upper surface.
Failure at WS 34.5L.

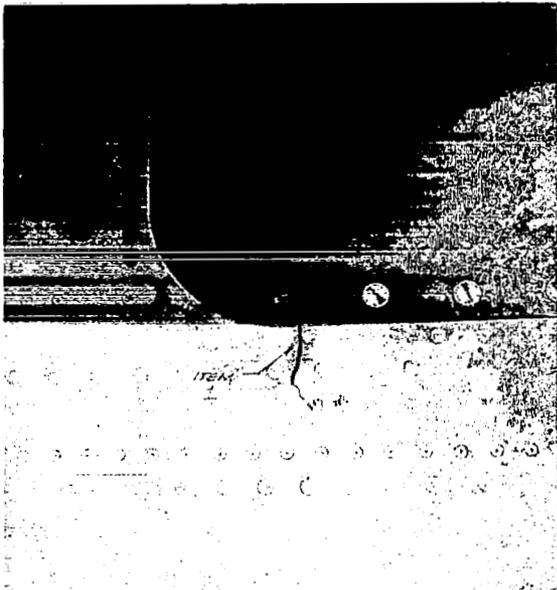
Figure 37.
Specimen #10.
Cyclic & static test,
upper surface.
Final crack at
corner of access
door, WS 198.5L.

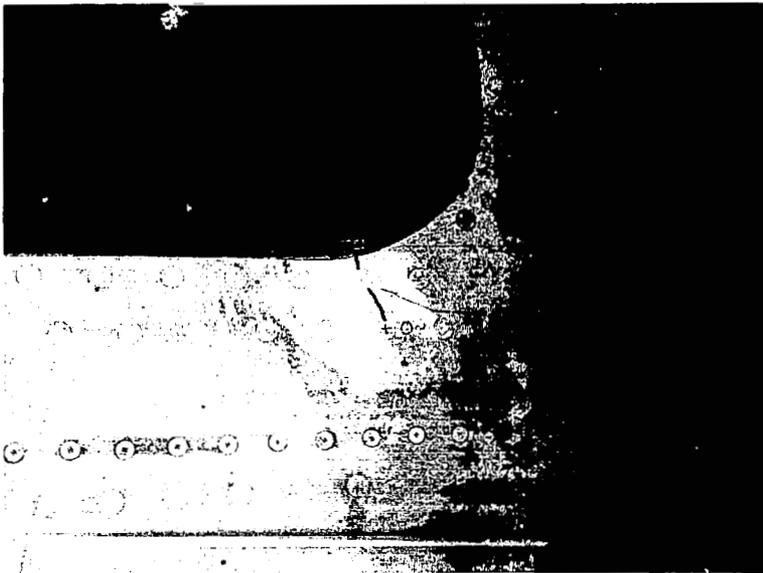
Figure 39.
Specimen #10.
Cyclic & static test,
upper surface.
Final crack at corner
of access door, WS 199R.

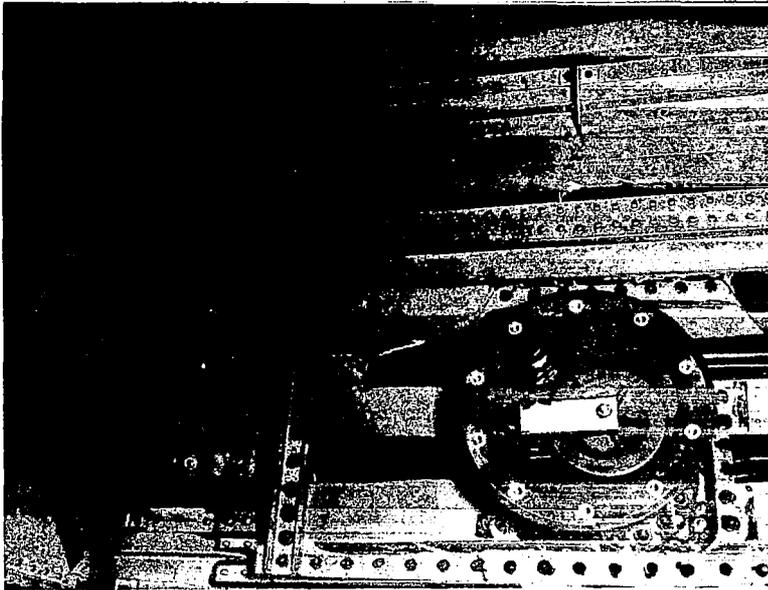
Figure 49.
Specimen #12.
Static & cyclic test,
upper surface.
Interior view of stringer
cracking, panels #1 and
#2, WS 105L - after test
cycling.

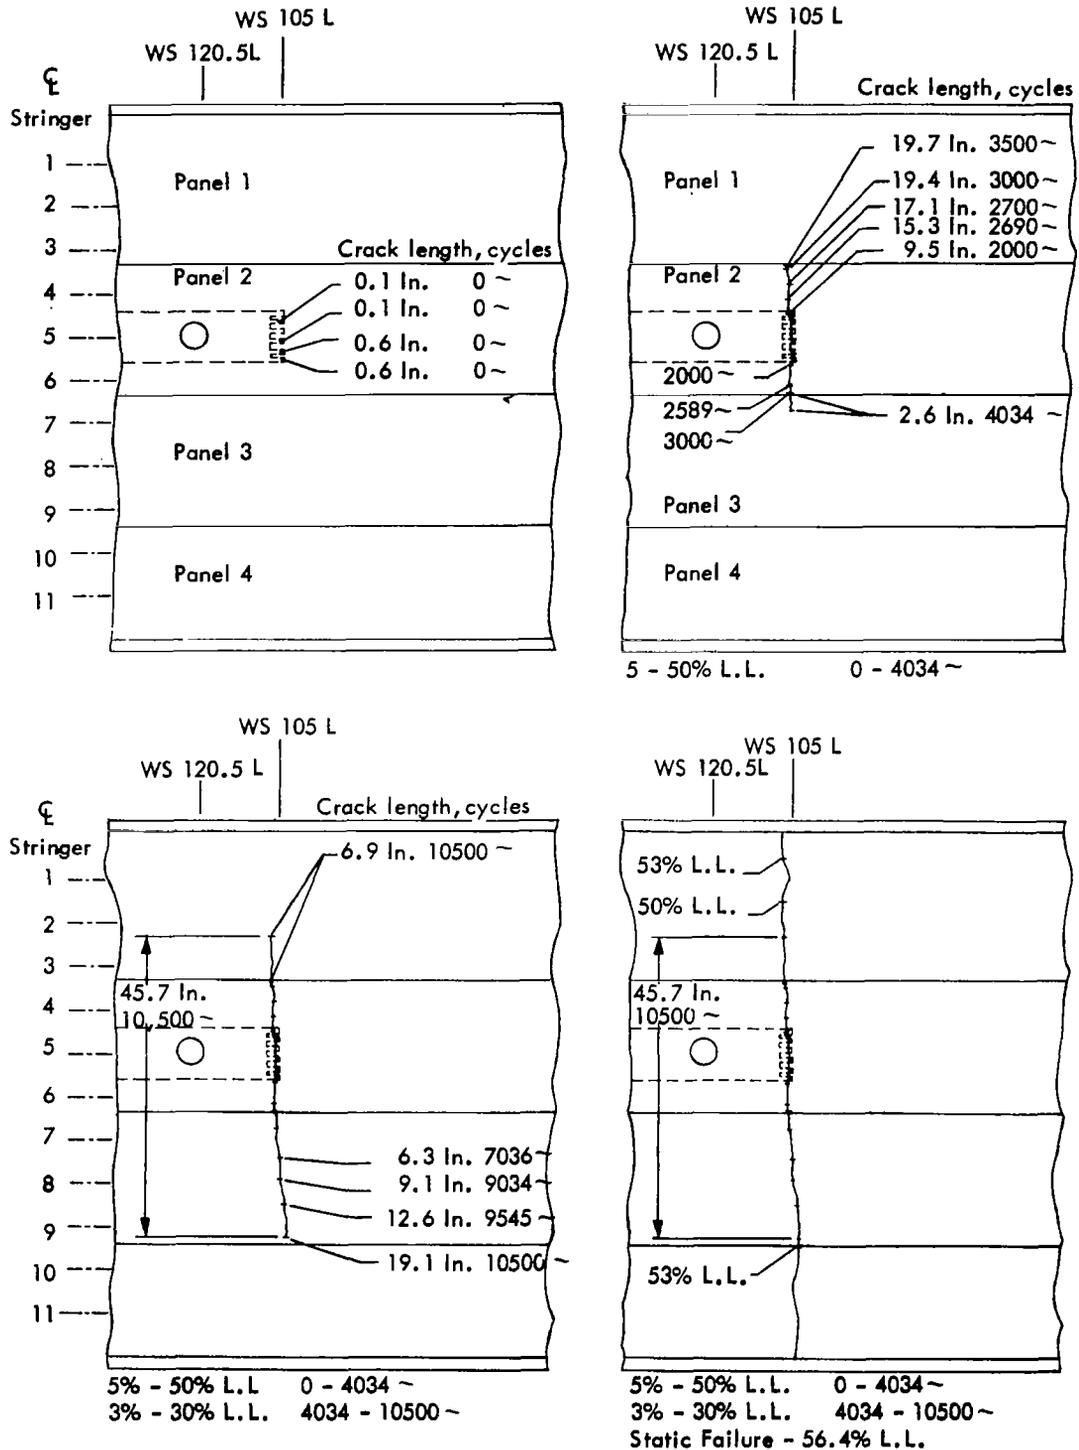
Figure 51. - Test specimen #12, progression of crack propagation to failure at W.S. 105 L.
